# Low carbon heritage buildings

## Case studies

These case studies are designed to complement the 'Low carbon heritage buildings: a user guide' by demonstrating how typical Yorkshire archetypes can be made low carbon without destroying their heritage value.

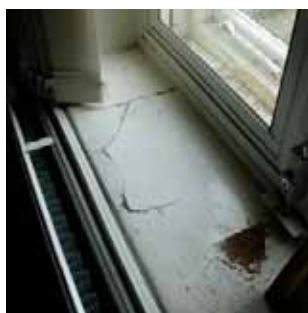
#### Glazing in office

Significant deterioration of window frames in places. Peeling of paint and draught strips not installed.

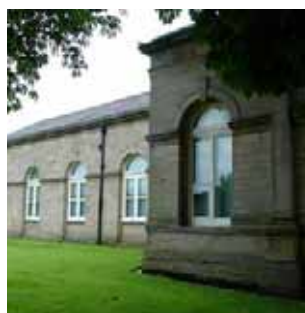
#### Main gallery external wall

North elevation in ashlar stone and currently in good condition. Historically significant elevation.

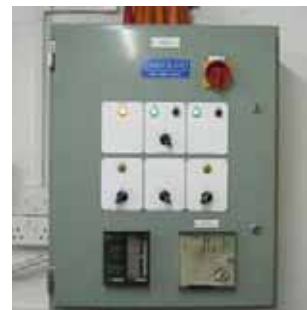
### Control panel

Lydis & Gyr automatic control system maintaining space temperature in gallery and office areas. Relative humidity is not controlled.

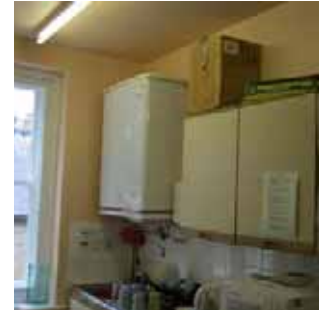
**Domestic hot water cylinder**

The building is served by mains cold water. The domestic hot water service is used to serve a kitchen and hand basins. An immersion heated hot water tank above the kitchen sink generates and stores domestic hot water. Approximately 100 litres of hot water is served. It is inefficient and carbon intensive in its current configuration. There is limited control of the domestic hot water system. Foil faced mineral wool fibre insulation is applied to domestic water pipework.

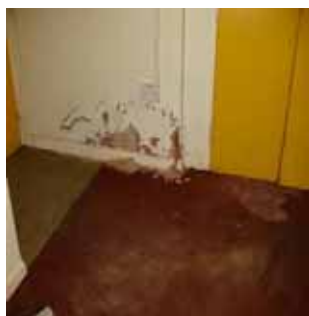
Water ingress at basement level.

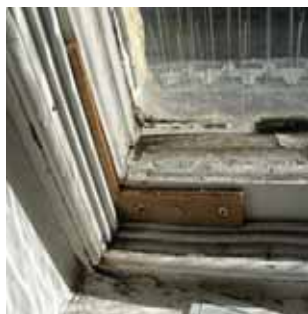
Some windows are in poor condition.

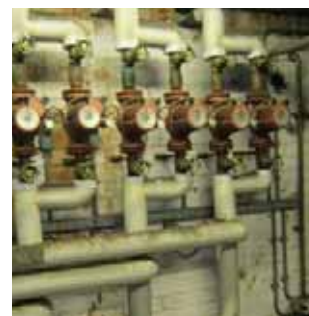
Duty and standby circulation pumps serving different zones.

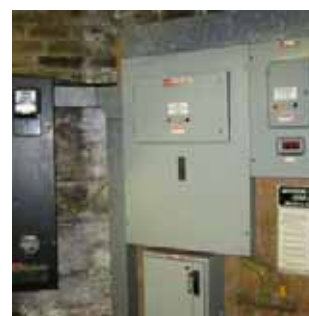
Incoming electrical supply in the boiler room.

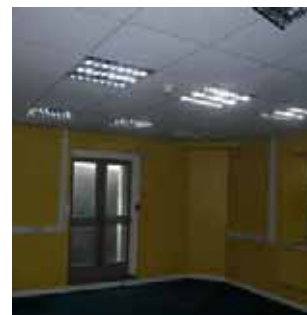
Internal wall lining to basement exterior wall.

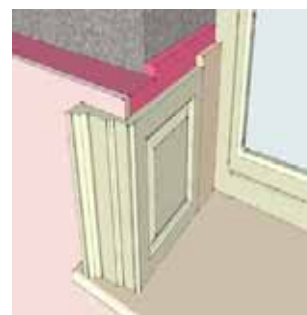
Internal wall insulation options would need careful detailing to contain new insulant (dark pink) behind removed and replaced window reveals.

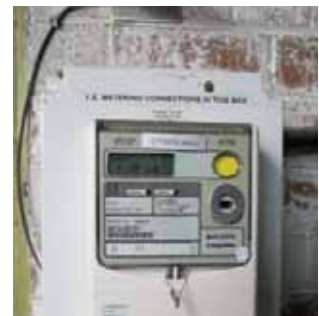
### Metering

A single meter for each fuel supplies the whole complex, reducing the possibility of isolating energy consumption.

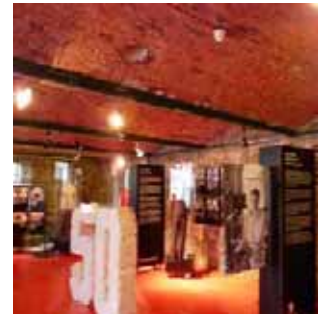
### Inefficient lighting

Dated tracked lighting scheme could be replaced with something significantly more efficient.

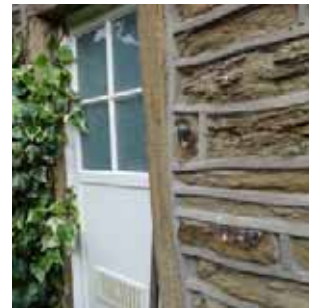
#### External walls

External walls are 575mm thick and of variable condition.

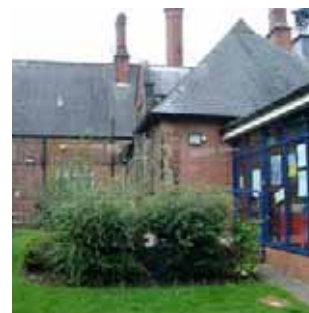
### Mixed history

Extensions have been added a number of times, often detracting from the attractive original building.
