## Case study: interior wall insulation

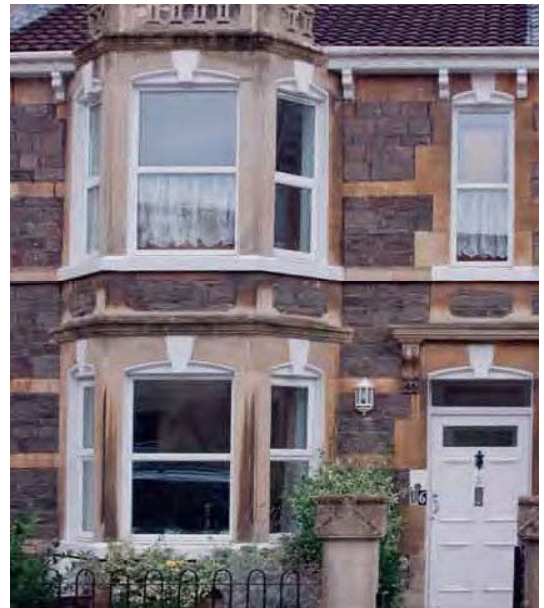
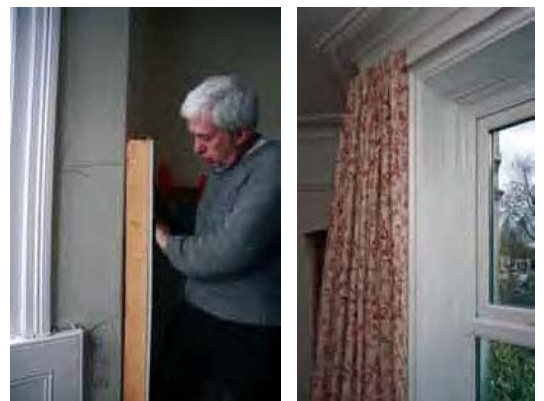
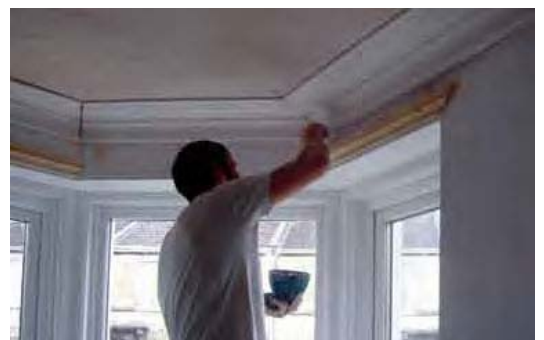
Although not a listed building, the house has character and this was respected. The insulation may have pushed the wall out (centre left) but the mouldings were restored (bottom) and the final result is arguably as good as new (centre right).

The material chosen was rigid phenolic board. This is a high performance synthetic insulation which is often used for wall insulation and supplied with plasterboard already in place on one side. Because it is such a good insulant, less depth is needed than other materials, which is an obvious benefit if you do not want to lose too much of the room space. The use of this 110mm wall insulation improved the thermal resistance of the wall by a factor of ten, resulting in a wall with lower thermal conductivity than a wall built to modern building regulations.

The insulation was taken below the floorboards and between the joists, to reduce the risk of the floor junctions becoming 'cold bridges', and the ends of the joists were damp-proofed. Similarly the insulation was extended back from the exterior walls along the party walls to reduce heat losses through these walls. At all window and door junctions, the detailing of the insulation has been thorough to ensure that the blanket is as comprehensive as possible. And indoor humidity is kept low with careful ventilation.
