# Low carbon heritage buildings

## Case studies

These case studies are designed to complement the 'Low carbon heritage buildings: a user guide' by demonstrating how typical Yorkshire archetypes can be made low carbon without destroying their heritage value.

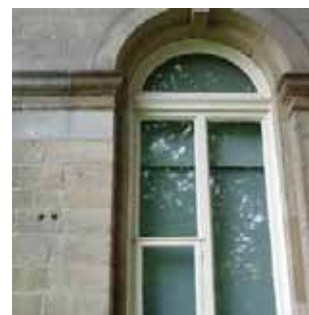
### Arched glazing in gallery space

Single glazed arched windows are part of the high significance of principal elevations.

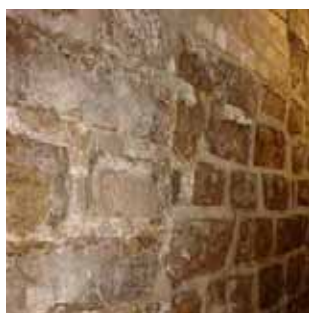
#### Basement external wall

Poor quality re-pointing with cementitious mortar.

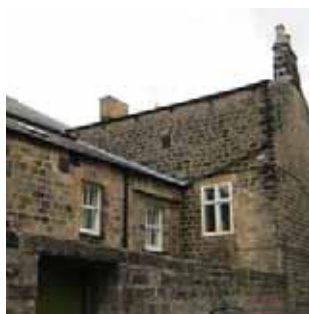
#### Office elevation

Southern elevation with rooflights above office. Less significant elevation and a number of ventilation louvres installed.

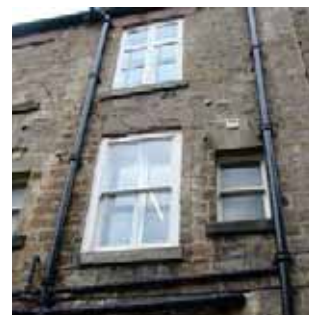
### Glazing at rear elevation

Rear facade is less sensitive than front elevation. Secondary glazing installed to offices.

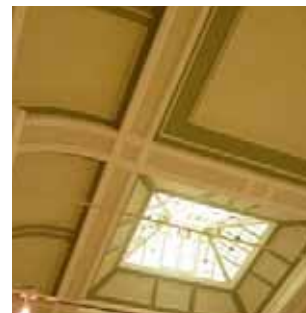
### Elaborate lay light in gallery

Patent glazing' 'Reinstating natural lighting through the lay lights would reduce electricity consumption – they are currently electrically lit.

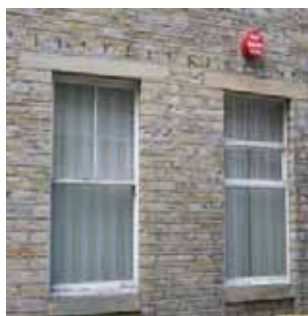
Different types of existing glazing.

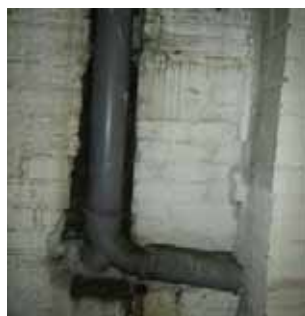
Drainage pipework recessed into wall.

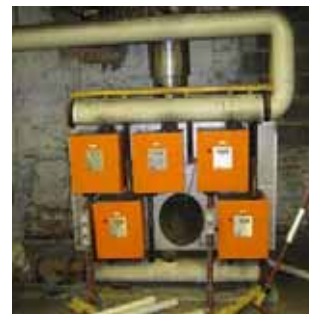
Modular gas fired boiler.

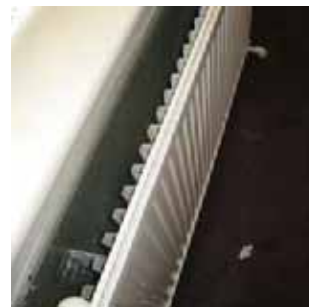
Reflective foil behind panel radiator.

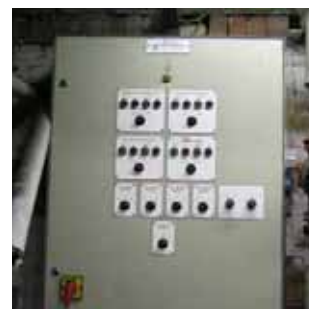
Control panel with partially stripped pipework.

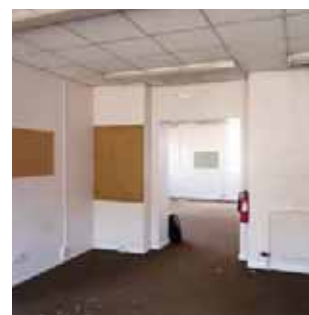
Office partitions and suspended ceiling.

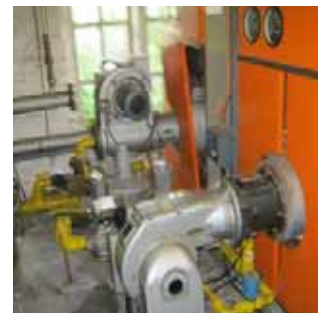
### Boiler plant

The heating plant has reached the end of its economic life, creating an opportunity for replacement with a lower-carbon system.

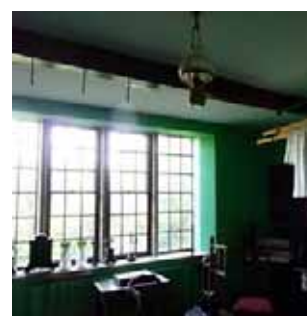
### Inefficient lighting

Dated tracked lighting scheme could be replaced with something significantly more efficient.

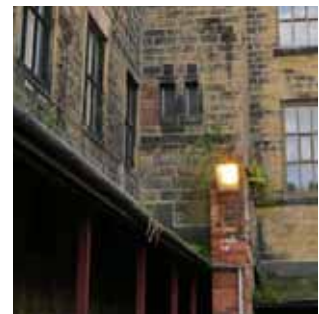
### Lack of adequate controls

External lighting on during the day highlights the need for more advanced control systems or behaviour change.

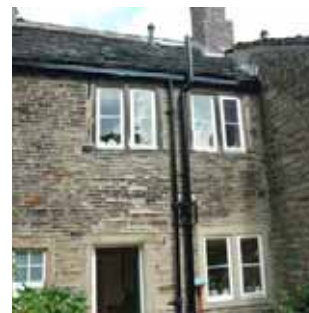
#### Rear elevation

Alterations have reduced the heritage significance of the rear of the property.

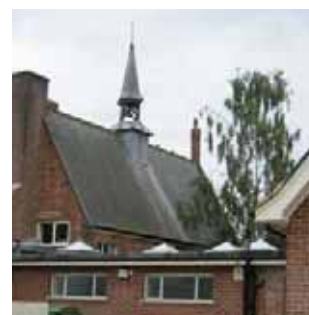
### Roof landscape

The 1950s building and later extensions are of cavity wall construction. The two classrooms in the former share a pitched, slated roof and the latter have flat felted roofs that have a long history of leaks and, if retained should be re-covered. The 1950s building has approximately 100 mm of loft insulation. It appears that the remaining buildings have no roof insulation.

The roofs of the extensions all have insufficient insulation and some are in poor condition.

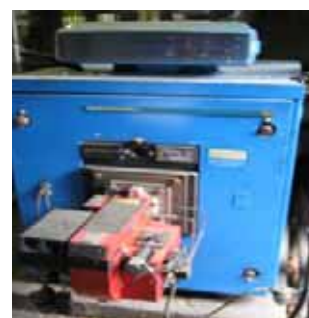
#### Inefficient heating system

The inefficient oil-fired boilers are a carbon-intensive way of providing heat and hot water.

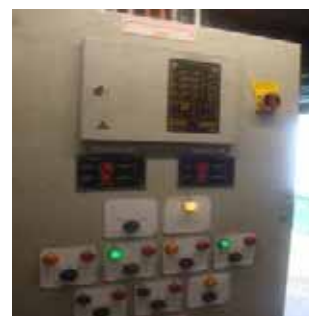
#### Boiler controls

The boiler control systems does not include features that would result in lower carbon emissions.

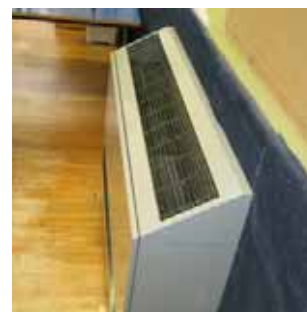
**Fan convector units**

Heating is provided by panel radiators and fan convectors. The fan convectors installed within the school are noisy. The staff regularly switched them off to avoid noise nuisance and consequently comfort conditions are not achieved.

Noisy heating units are often switched off to void nuisance, leading to cold conditions.

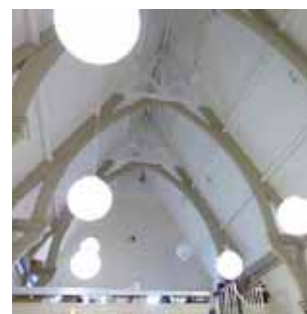
**High ceilinged old school hall**

The old school hall includes a bell tower which previously provided natural ventilation but has been blocked up. Windows in the hall are not currently operable. Both should be reinstated to provide ventilation to the school hall. Wind assisted natural ventilation through the turret should be better controlled by adding adjustable electrically operated dampers for temperature control. De-stratification fans should be installed at high level in the hall to move heat trapped at high level to low level.

Temperature gradients in high ceilinged spaces can lead to cool conditions at ground level. A destratification fan can be used to mix air and spread warmth.

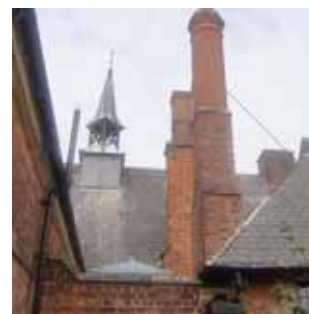
#### Natural ventilation strategy

Former roof ventilator could be reinstated to complement a natural ventilation strategy.

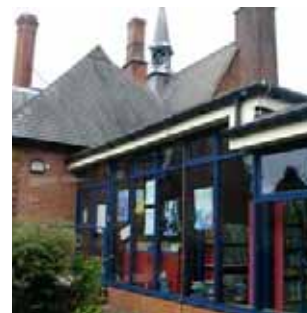
### Modern extensions

Some later additions do little to add to the character and value of the original 19th century building.

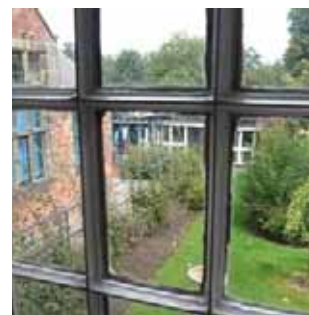
### Secondary glazing

The incorporation of secondary single glazing could significantly improve the thermal properties of heritage windows.

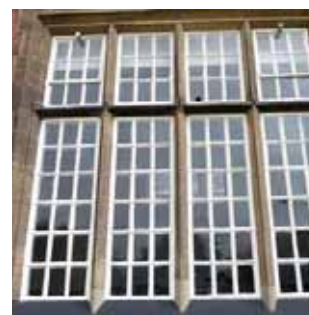
### Mullioned window

Mullioned windows along with arched doorways add to a picturesque character.
